Report No. FAA-RD-79-86
WES TR GL-79-24

FIELD TESTS OF PLASTIC PIPE FOR AIRPORT DRAINAGE SYSTEMS

Walter J. Horn

U. S. Army Engineer Waterways Experiment Station
Geotechnical Laboratory
P. O. Box 631, Vicksburg, Miss. 39180

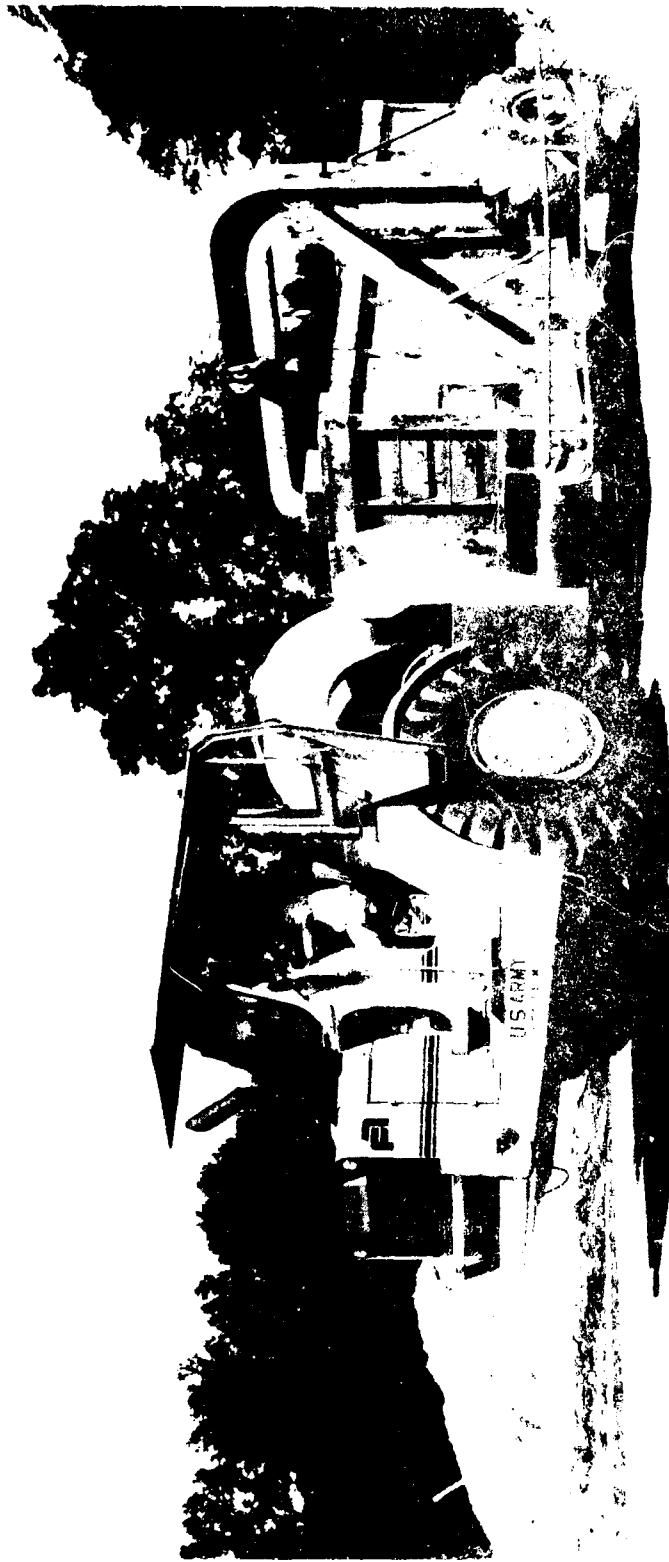
Figure 19. Load cart simulating C-141 aircraft load

The second load cart (Figure 19) used during the field tests at Test Site No. 2 simulated the load that would be applied by the C-141 aircraft. Using this load cart, a load of 144,000 lb was transmitted through 4 wheels (32.5- by 48-in. spacing) to the surface of the test site. Tire pressures of 180 psi were used on this load cart.
